TRAFFIC SAFETY STUDY

ACCIDENT LOCATIONS

CASCADE COUNTY, MONTANA

DEPARTMENT OF JUSTICE CONTRACT NO. 89-06-02-1

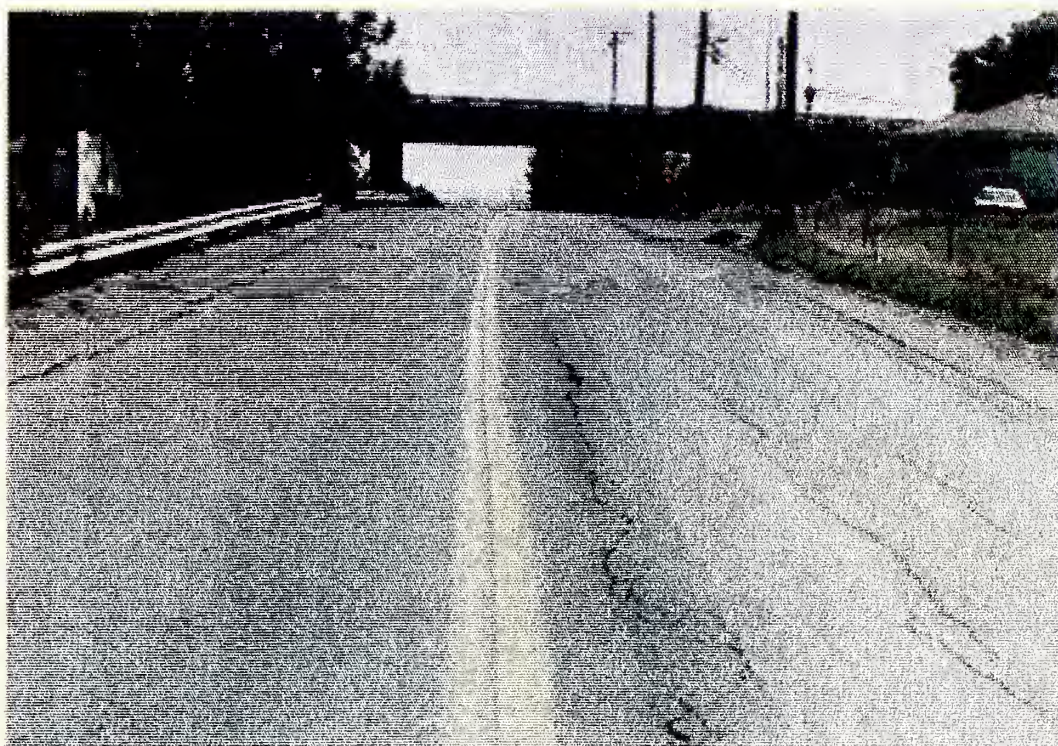
SITE 14: Flood Road approximately 500' north of 18th Avenue Southwest looking south. This photo is taken approximately from the north end of guardrail on the east side of Flood Road. The 18th Avenue Southwest intersection is not yet visible from this location. (4/16)

- Replace the existing WB guardrail and object markers on the east side of 14th St. SW with curb, gutter and sidewalk;
- Extend curb, gutter and sidewalk along 18th Ave. SW from 14th St. SW to across the railroad track to the suburban development near Treasure State Drive;
- Install new curb, gutter and sidewalk along the west side of 14th St. SW from the Airway Hotel north to 16th Ave. SW.

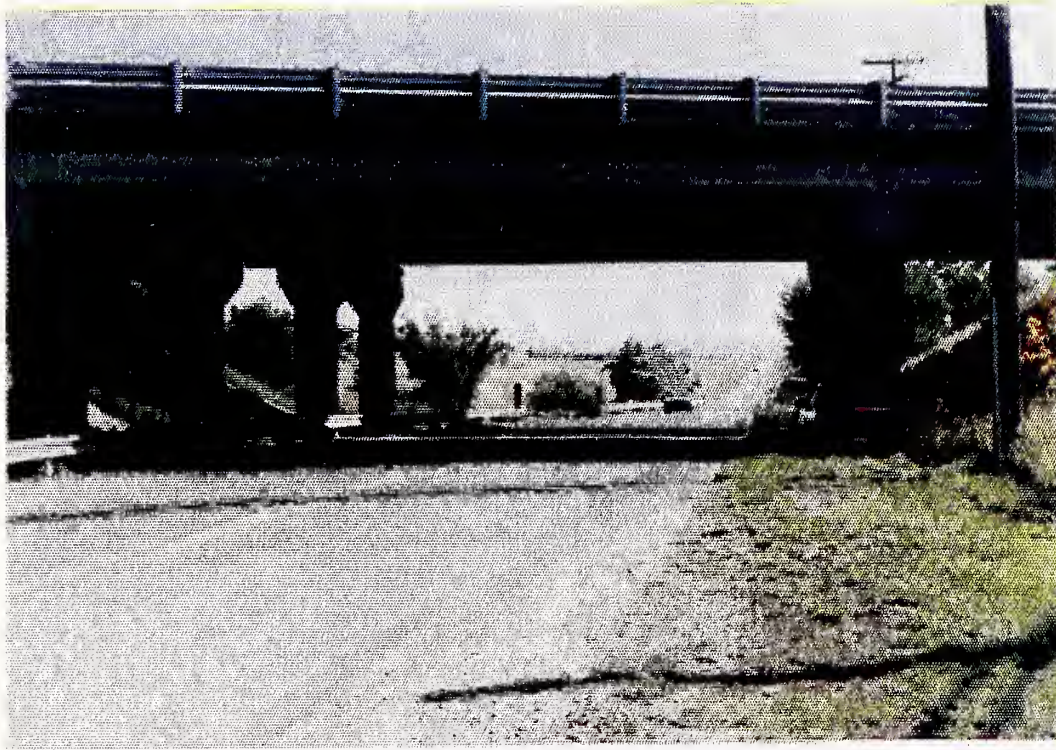
SITE 14: From the southwest corner 17th Avenue Southwest and Flood Road looking southeast. (4/18)

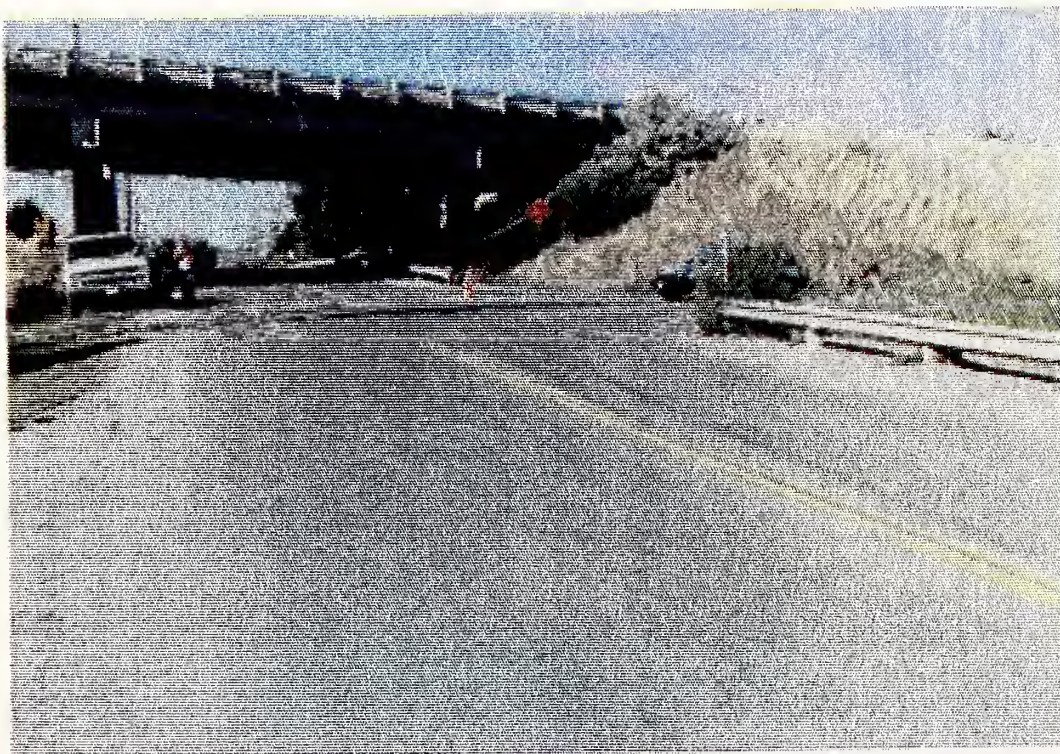
SITE 14: From the west side of Flood Road approximately 150' south of 18th Avenue Southwest looking north. Notice the position of the stopped vehicle relative to the westbound stop sign. (4/19)

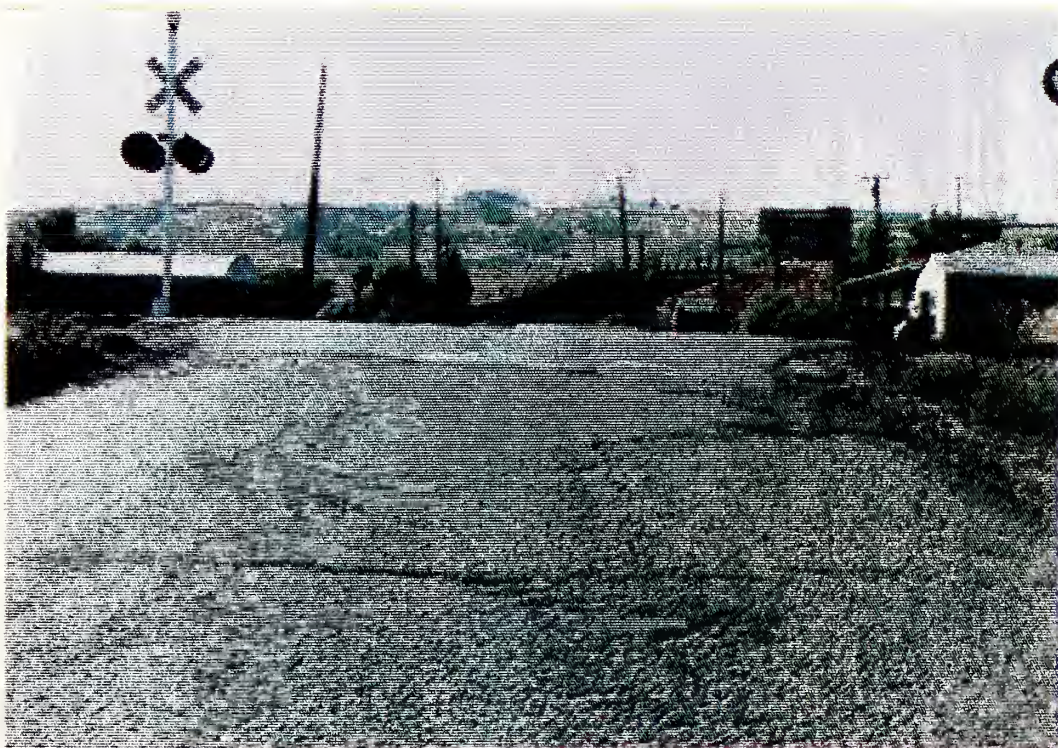
SITE 14: From 18th Avenue Southwest, 80' east of the railroad crossing looking west from the approximate drivers eye height. (4/23)

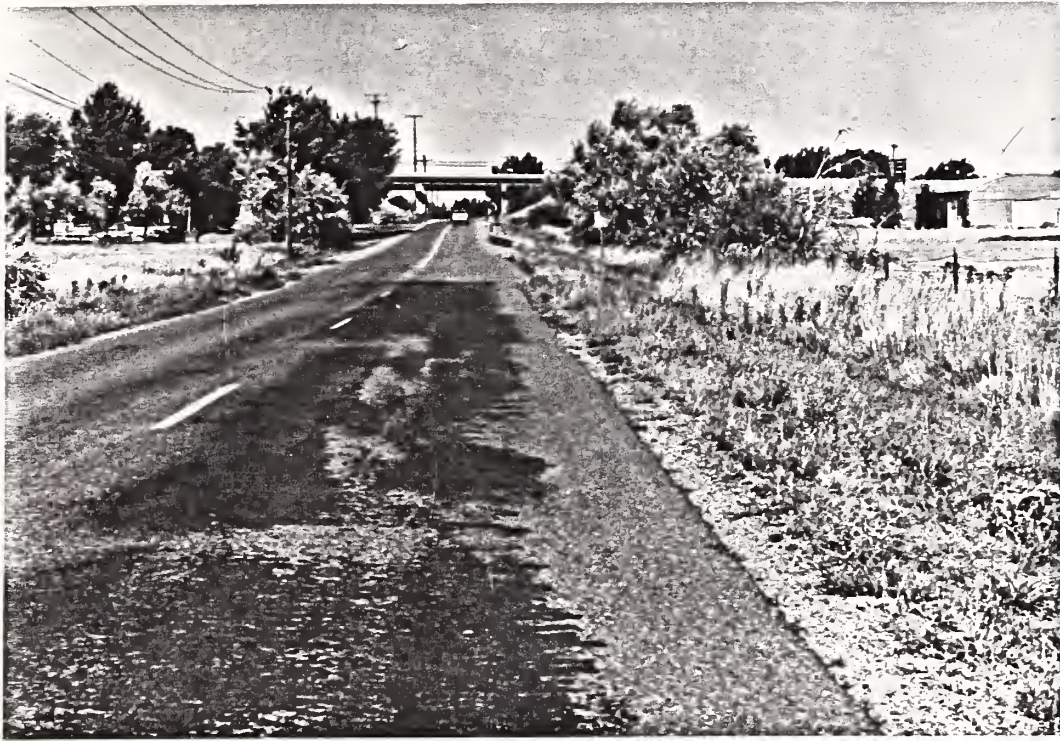
SITE 14: Flood Road approximately 600' south of the highway overpass looking north. Notice the speed limit sign is barely visible on the right. (5/20)

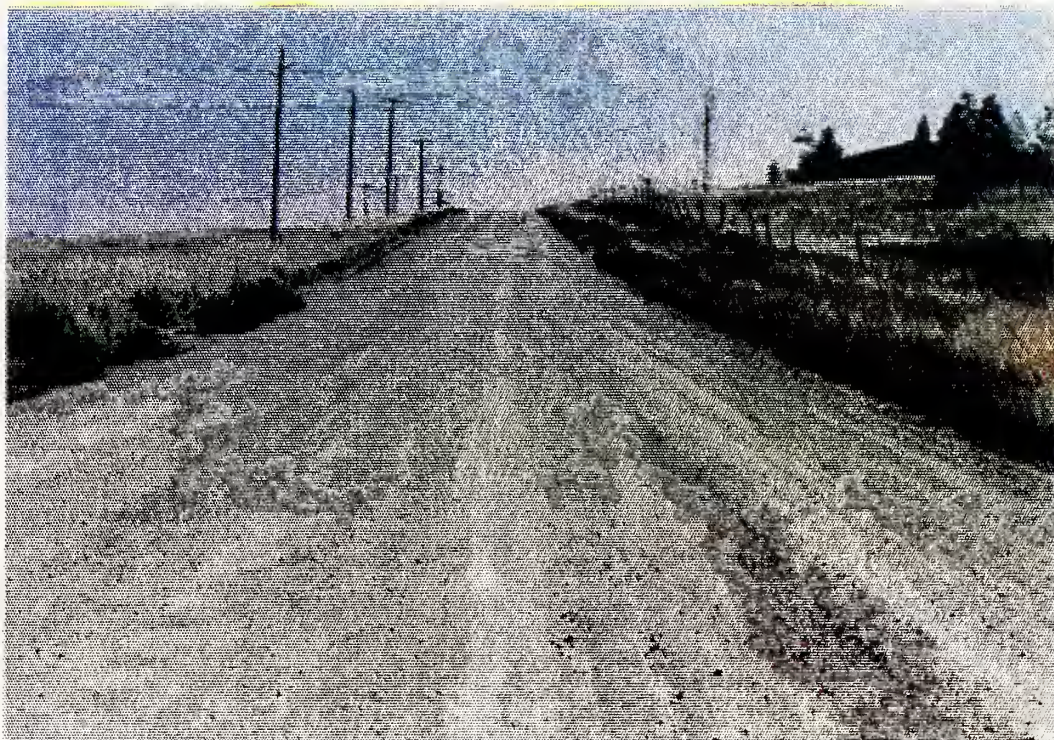
- Sight distance due to the crest vertical curve in the north leg of the intersection;
- Roadway condition (icy);
- Inattentive driving for roadway conditions.

SITE 15: On 45th Avenue SW approximately 750' west of Fox Farm Road looking east. Notice the intersection is not visible due to the crest of the hill. (4/4)

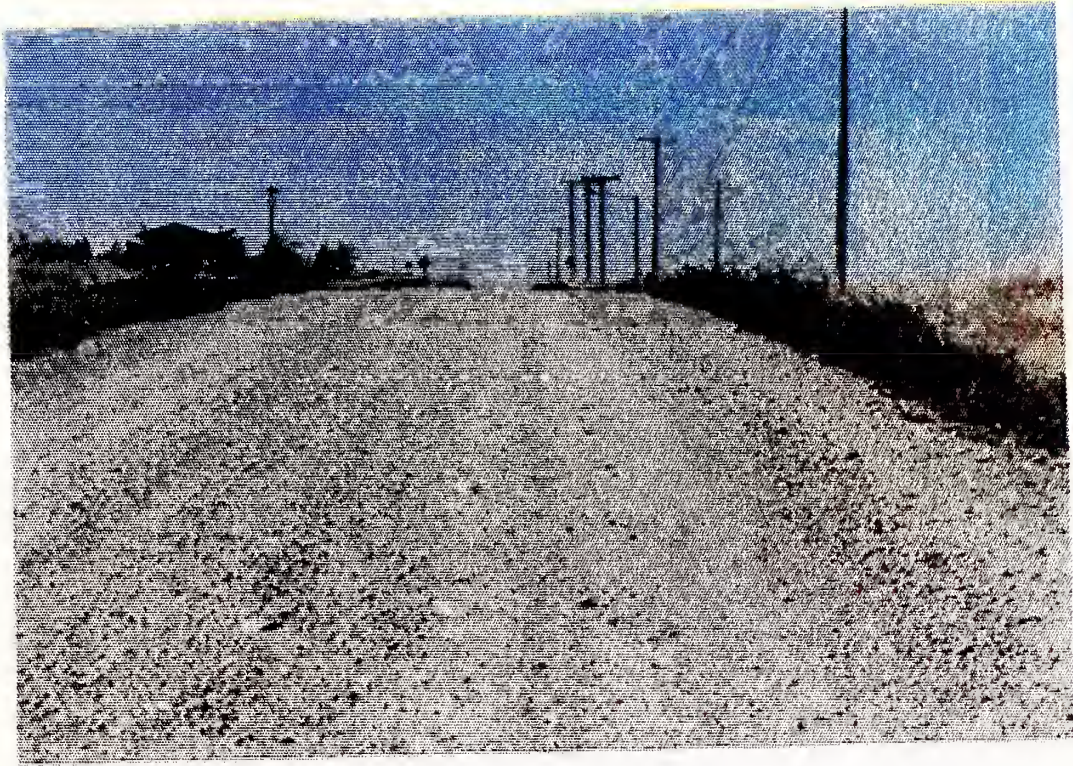
SITE 15: 45th Avenue SW approximately 300' east of Fox Farm Road where the Fox Farm Road pavement becomes visible. Taken from the drivers eye height looking west. Due to the cut slope in advance of Fox Farm Road mainline vehicles can only be seen for a short time immediately at the intersection. The stop sign and intersection is obscured from the drivers view when going up the hill in the foreground. (4/8)

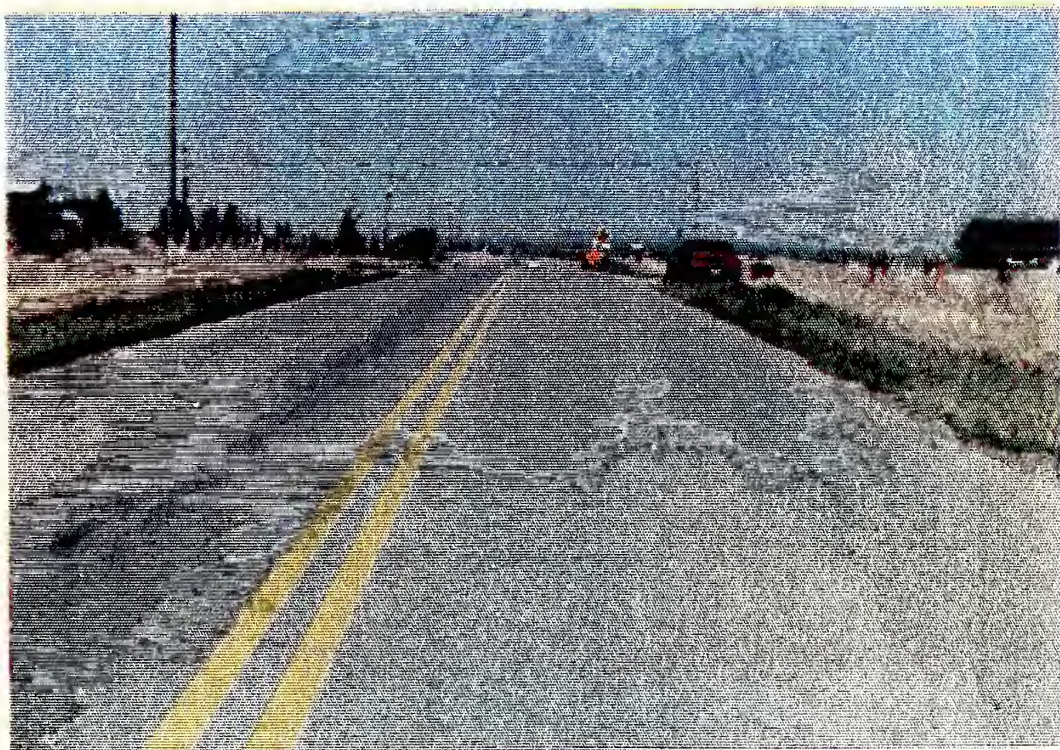
SITE 15: Fox Farm Road south of 45th Avenue SW looking north. From this location cars temporarily drop out of sight in advance of 45th Avenue SW and then reappear just before crossing 45th Avenue SW due to the sag vertical curve approximately 400' south of 45th Avenue SW. (4/9)

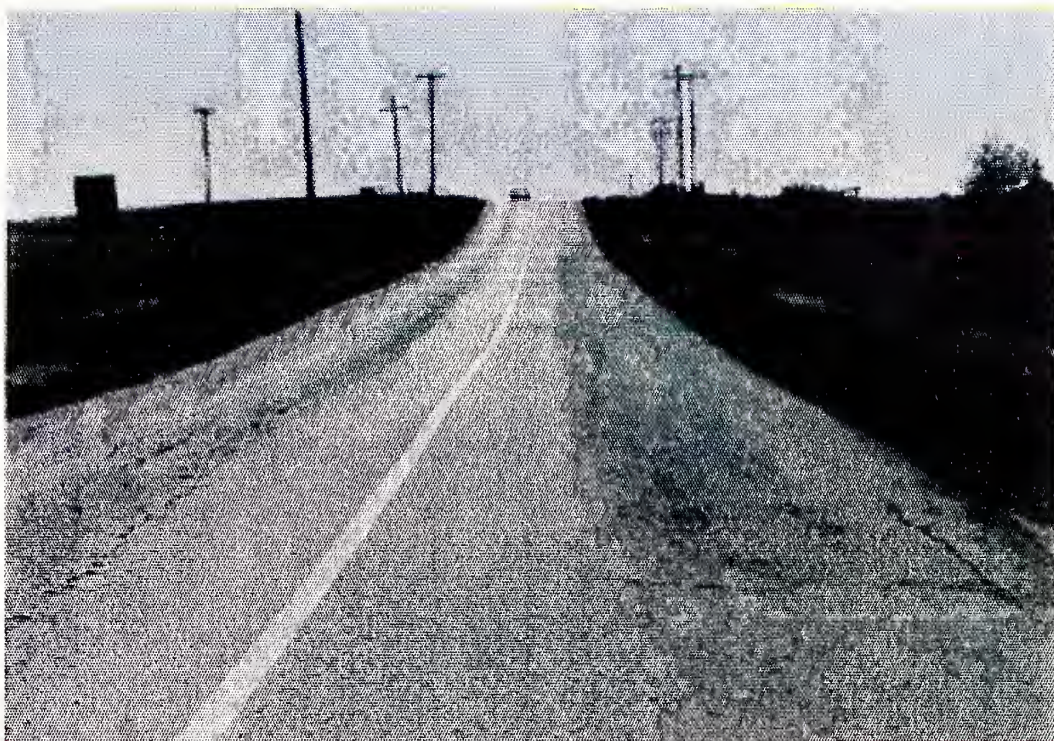
SITE 15: Fox Farm Road approximately 400' north of 45th Avenue SW looking south. (4/12)
